Successful Management of a Broken Stylet Retained in Tracheobronchial Tree: A Case Report

Hsien Yung Lai, Successful Management of a Broken Stylet Retained in Tracheobronchial Tree: A Case Report. *Ann Clin Med Case Rep.* 2022; V9(15): 1-4

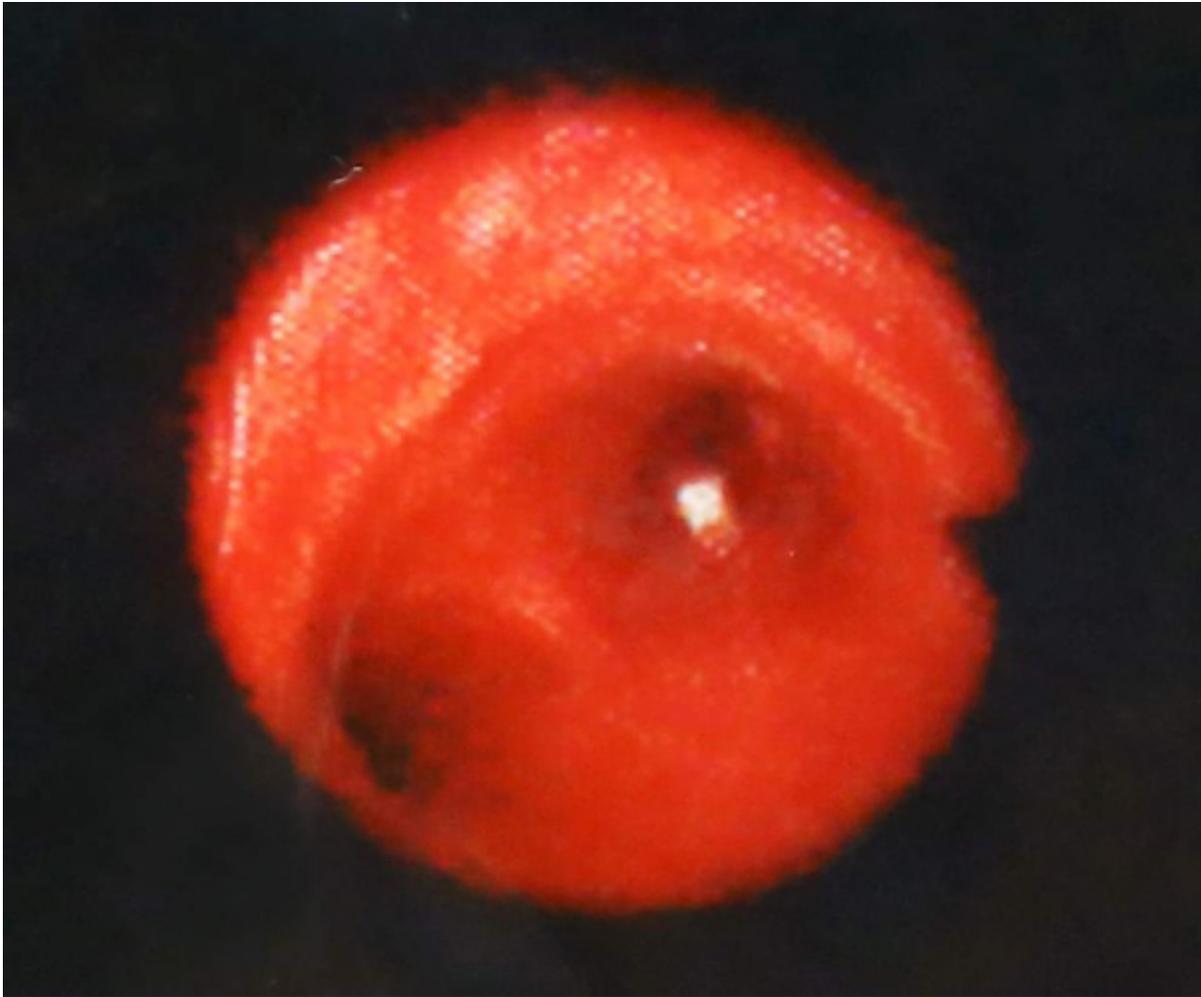
The anesthesiologist decided to go ahead with fiberoptic bronchoscopy. The bronchoscopy revealed a metallic mobile foreign body in the right main bronchus (Figure 1). The foreign body then was retrieved with biopsy forceps and brought up into the endotracheal

Figure 1: Metallic foreign body seen in the right main bronchus.

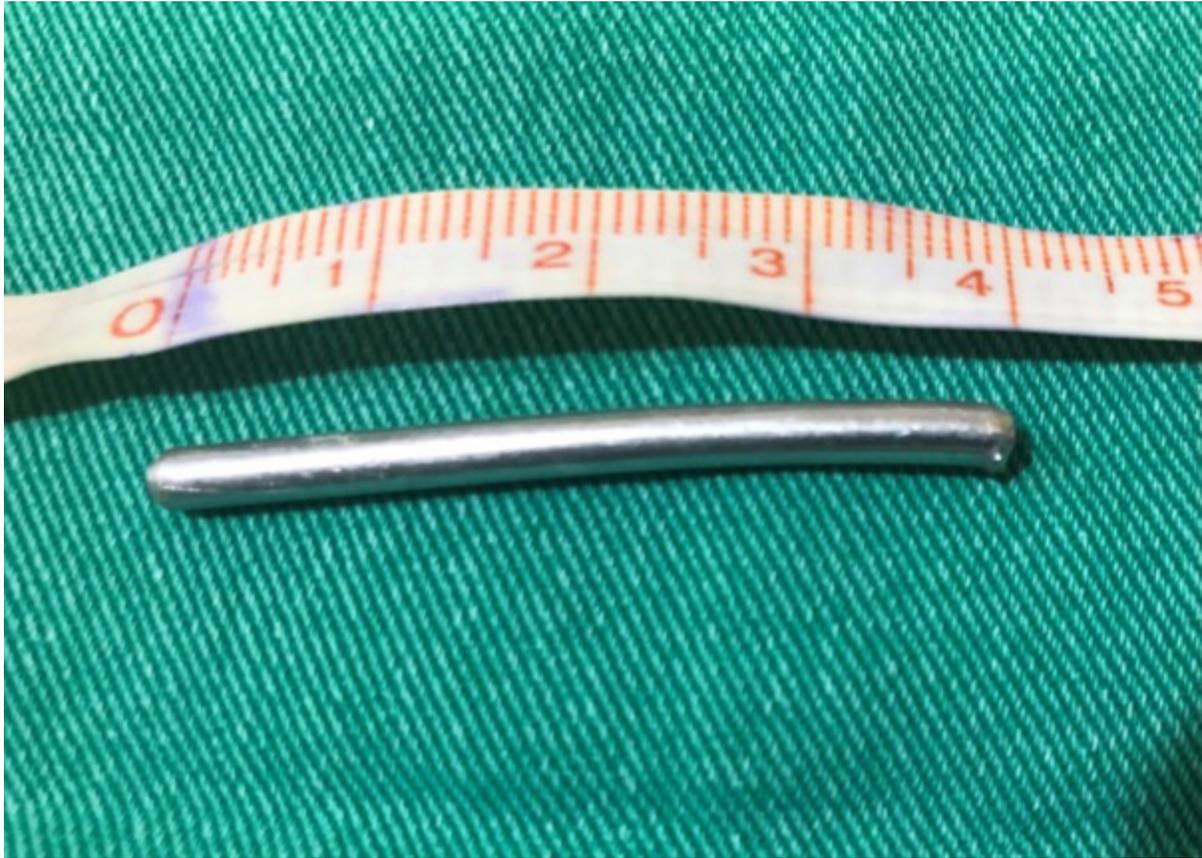
tube and then removed successfully via the endotracheal tube. The foreign body was an aluminum rod about 4 cm in length and 2.5-3 mm in diameter (Figure 2). It looked like the malleable stylet and matched the size with the residual stylet (Figure 3). There was no bleeding or mucosa injury during the procedure. After removal, check bronchoscopy was performed, and the airways visualized both the sides up to the sub segmental level were all clear. Then the surgery was proceeded which lasted for 115 minutes and the intra-operation period remained uneventful. After completion of surgery, he was extubated and sent to the post operating recovery room smoothly. No cough, dyspnea and desaturation was noted.

Figure 2: Removed broken piece of stylet from patient's right main bronchus.
